Inspection Report

Property Address:
123 Any Street
Hometown IL 60000

Carroll Inspections Inc.

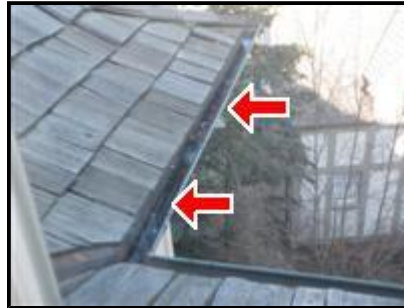
1.3 Picture 1

1.3 The gutters are full of debris in areas and needs to be cleaned. The debris in gutters can also conceal rust, deterioration or leaks that are not visible until cleaned, and I am unable to determine if such conditions exist.

The gutters are full of debris in areas and needs to be cleaned. The debris in gutters can also conceal rust, deterioration or leaks that are not visible until cleaned, and I am unable to determine if such conditions exist.

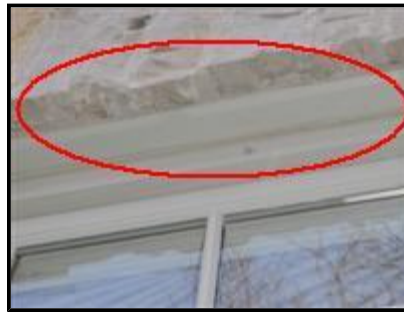
2.0 Picture 1

2.0 (1) Missing weeps at various locations on the out side of the house. Monitor for moisture. If any problems arise have a licensed masonry contractor review and repair .

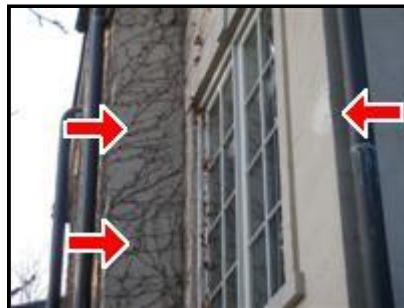
2.0 Picture 2

(2) There is a patch on the stucco on the north east corner of the house. There is also vines growing on the house that should be removed as to not cause damage to the stucco. Have reviewed and repaired by a licensed EIFS contractor.

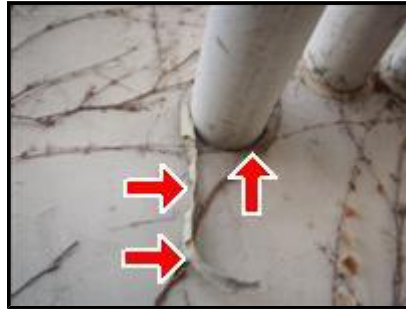
2.0 Picture 3

(3) Caulking has failed around the furnace vent pipe on the south side of the home. Have reviewed and repaired by a licensed contractor.

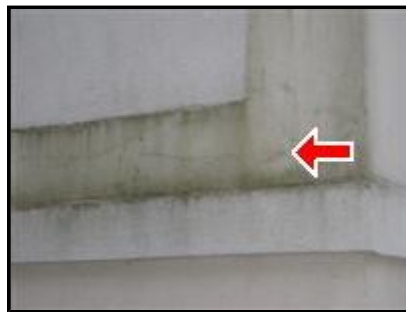
2.0 Picture 4

(4) The EIFS system on the north side of the house shows signs of fungus growth. Being the growth is on the north side of the house I would recommend to have it cleaned and reviewed by a licensed EIFS contractor.

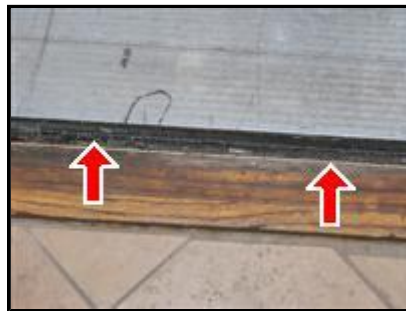
2.1 Picture 1

2.1 (1) The main entry door is damaged at weather-stripping. This can cause some heat loss in winter and loss of cool air in summer if not corrected. A qualified person should repair or replace as needed.

- (1) The main entry door is damaged at weather-stripping. This can cause some heat loss in winter and loss of cool air in summer if not corrected. A qualified person should repair or replace as needed.

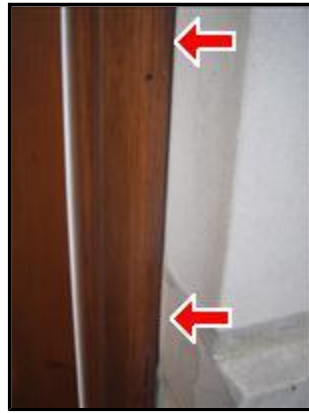
2.1 Picture 2

(2) The main entry door needs caulking along top and sides of trim (exterior). This is a maintenance issue and is for your information. A qualified person should repair or replace as needed.

(2) The main entry door needs caulking along top and sides of trim (exterior). This is a maintenance issue and is for your information. A qualified person should repair or replace as needed.

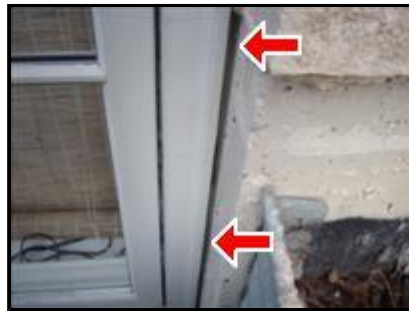
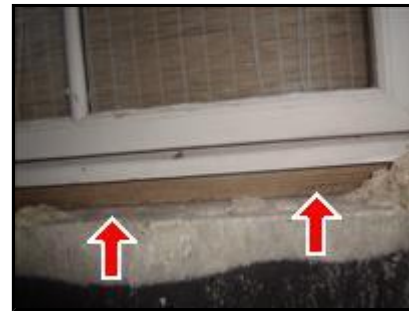
2.2 Picture 1

2.2 The three basement windows on the south west side of the home were never finished during construction. The windows are in need of caulking and final trim installed around all three windows. Have reviewed and repaired by a licensed contractor.

The three basement windows on the south west side of the home were never finished during construction. The windows are in need of caulking and final trim installed around all three windows. Have reviewed and repaired by a licensed contractor.

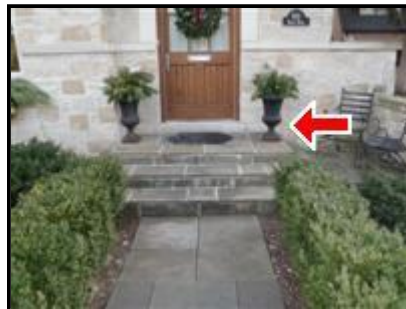
2.3 Picture 1

2.3 The hand/guard rail for the front walk stairs is missing. A fall or injury could occur if not corrected. A qualified contractor should repair or replace as needed.

The hand/guard rail for the front walk stairs is missing. A fall or injury could occur if not corrected. A qualified contractor should repair or replace as needed.

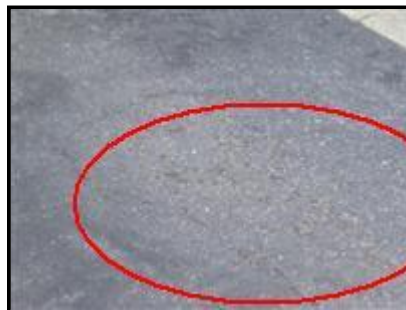
2.4 Picture 1

2.4 The asphalt drive at the left side (facing front) is pitted in areas. Water can cause further deterioration if not repaired and sealed properly. A qualified person should repair or replace as needed.

The asphalt drive at the left side (facing front) is pitted in areas. Water can cause further deterioration if not repaired and sealed properly. A qualified person should repair or replace as needed.

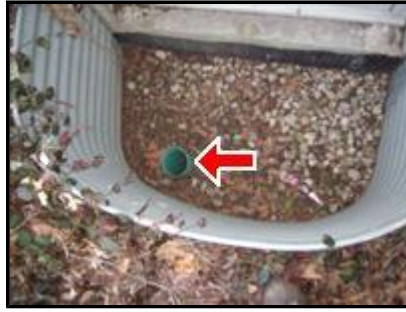
2.6 Picture 1

2.6 Missing cover for window well drain on south west window well.the cover stops debris from entering pipe and lets the water flow.Have reviewed and repaired by a licensed contractor.

Missing cover for window well drain on south west window well. The cover stops debris from entering pipe and lets the water flow. Have reviewed and repaired by a licensed contractor.

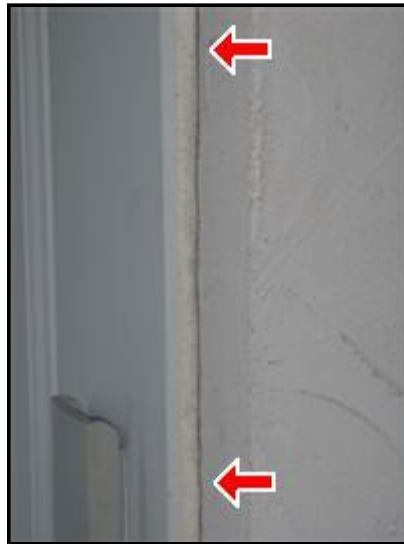
3.3 Picture 1

3.3 The trim around the garage overhead door need to be re caulked. Have reviewed and repaired by a qualified contractor.

The trim around the garage overhead door needs to be re-caulked. Have reviewed and repaired by a qualified contractor.

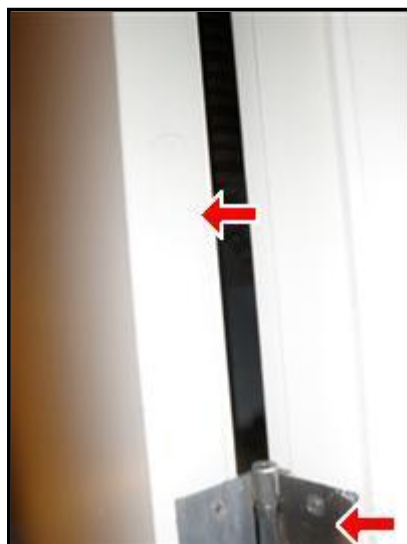
3.4 Picture 1

3.4 The door to the garage looks to have a label on the door that has been painted over and we can not tell if it is a B label fire door. The door is also missing self closing hinges. Have reviewed and repaired by a licensed contractor.

The door to the garage looks to have a label on the door that has been painted over and we can not tell if it is a B label fire door. The door is also missing self-closing hinges. Have reviewed and repaired by a licensed contractor.

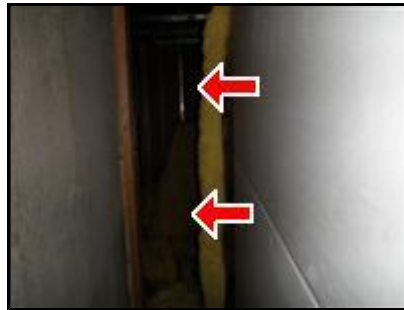
4.1 Picture 1

4.1 (1) Insulation has fallen from the walls in the basement behind the bar. Have re installed be a licensed contractor.

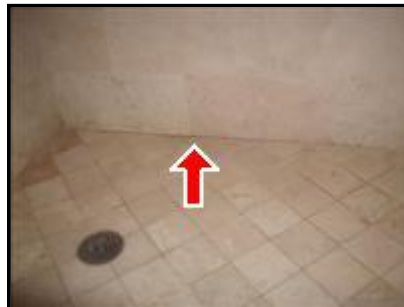
4.1 Picture 2

(2) The Tile surround at shower on the wall has missing or loose grout at the master bath. Repairs are needed. A qualified person should repair or replace as needed.

(2) The tile surround at shower on the wall has missing or loose grout at the master bath. Repairs are needed. A qualified person should repair or replace as needed.

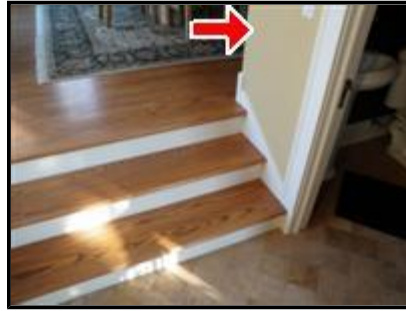
4.3 Picture 1

4.3 (1) The hand/guard rail for the foyer is missing. A fall or injury could occur if not corrected. A qualified contractor should repair or replace as needed.

(1) The hand/guard rail for the foyer is missing. A fall or injury could occur if not corrected. A qualified contractor should repair or replace as needed.

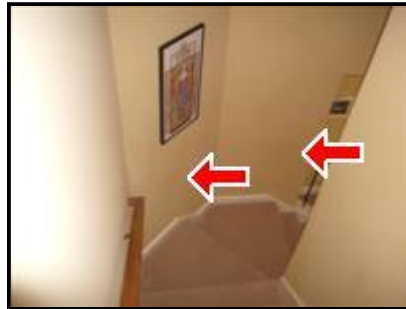
4.3 Picture 2

(2) The hand/guard rail for the third story stairs is missing. A fall or injury could occur if not corrected. A qualified contractor should repair or replace as needed.

(2) The hand/guard rail for the third story stairs is missing. A fall or injury could occur if not corrected. A qualified contractor should repair or replace as needed.

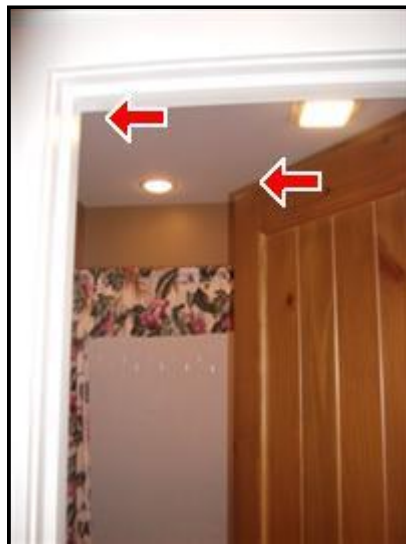
4.5 Picture 1

4.5 The Entry door rubs at top when closing at the Guest bath on the third floor. This is a maintenance issue and is for your information. A qualified person should repair or replace as needed.

The Entry door rubs at top when closing at the Guest bath on the third floor. This is a maintenance issue and is for your information. A qualified person should repair or replace as needed.

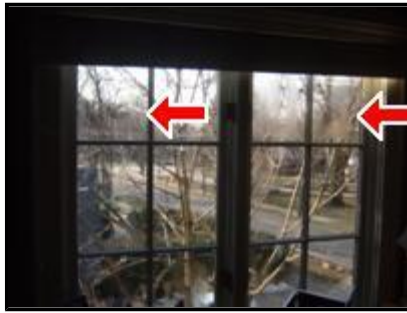
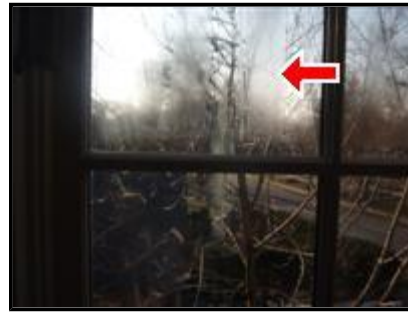
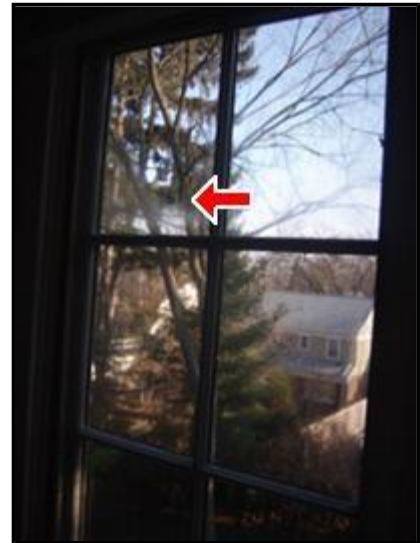
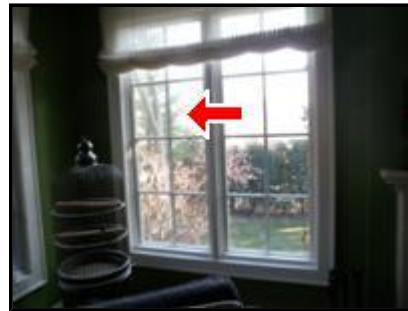
4.6 Picture 1

4.6 (1) Eight windows are cloudy (lost seal) at the family room, office closet, third floor south wall and front entry sitting area. In order to correct the cloudy appearance of glass, a replacement of glass pane or the unit will be necessary. A qualified person should repair or replace as needed.

(1) Eight windows are cloudy (lost seal) at the family room, office closet, third floor south wall and front entry sitting area. In order to correct the cloudy appearance of glass, a replacement of glass pane or the unit will be necessary. A qualified person should repair or replace as needed.

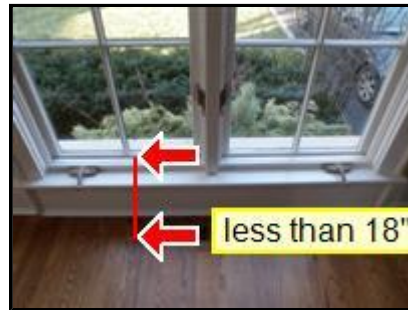
4.6 Picture 5

(2) The bottom of the windows in the dinning room are less then 18" to the ground.Windows that are less then 18"to the ground need to be tempered glass.Have reviewed and repaired by a licensed contractor.

(2) The bottom of the windows in the dining room are less than 18" to the ground. Windows that are less than 18" to the ground need to be tempered glass. Have reviewed and repaired by a licensed contractor.

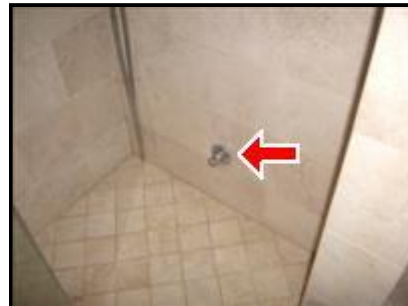
4.7 Picture 1

4.7 The steam pipe in the master shower is not connected to any unit.This is for your information only.The plumbing and electric is set up in the master closet to be installed at a later date.

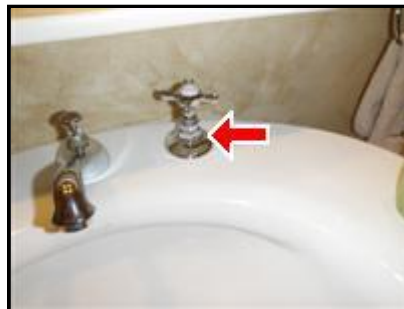
6.1 Picture 1

6.1 The sink faucets does not operate at the lower level bath. Repairs are needed. A qualified licensed plumber should repair or correct as needed.

The sink faucets does not operate at the lower level bath. Repairs are needed. A qualified licensed plumber should repair or correct as needed.

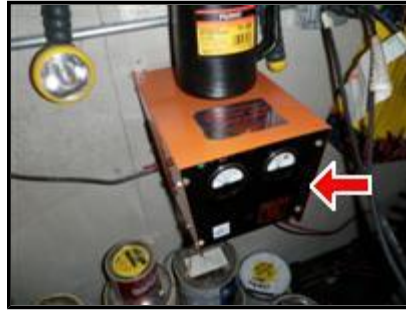
6.6 Picture 1

6.6 The battery back up system for the sump pump needs to be reviewed and repaired by a licensed plumber. Was not working at time of inspection.

The battery back up system for the sump pump needs to be reviewed and repaired by a licensed plumber. Was not working at time of inspection.

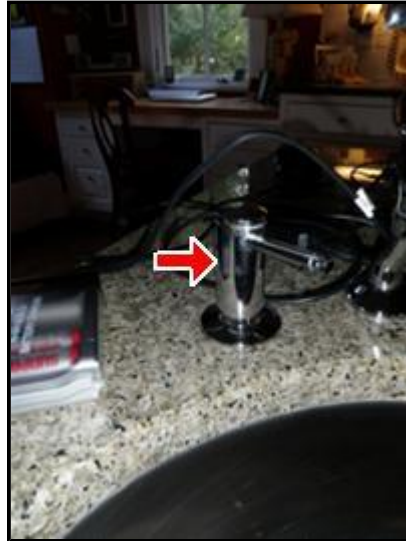
6.7 Picture 1

6.7 Was unable to get soap dispenser to work. Have reviewed and repaired by a licensed plumber.

Was unable to get soap dispenser to work. Have reviewed and repaired by a licensed plumber.

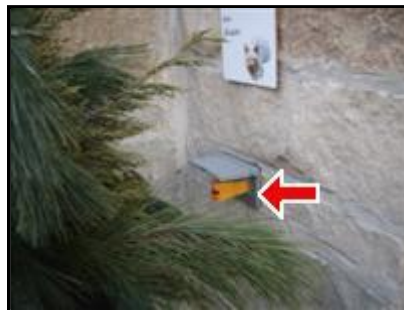
7.3 Picture 1

7.3 At least One GFCI (Ground Fault Circuit Interrupter) outlet at the main entry wont "trip" when tested. This is a safety issue that needs to be corrected. A qualified licensed electrical contractor should correct as needed.

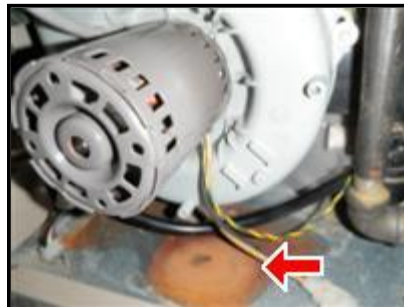
8.0 Picture 1

8.0 The furnace exhaust fan is in need of repair. Water was found in unit. Have reviewed and repaired by a licensed HVAC contractor.

The furnace exhaust fan is in need of repair. Water was found in unit. Have reviewed and repaired by a licensed HVAC contractor.

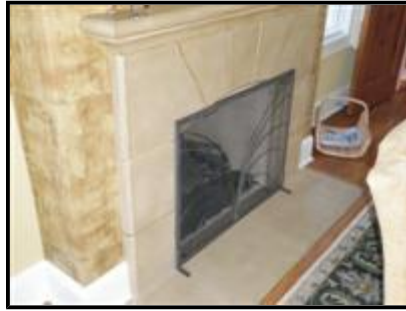
8.7 Picture 1

8.7 Was unable to turn the gas on at time of inspection. Ask home owners to show you how to turn on the gas at time of walk thru.

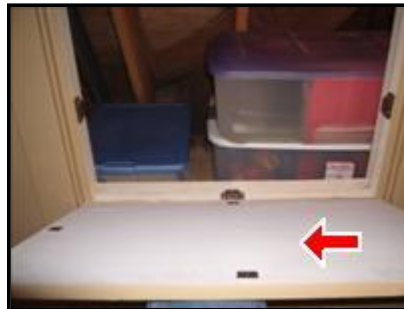
9.0 Picture 1

9.0 Access panel doors are missing insulation on the backs of them. Cold air is allowed to migrate through the panel and into the third floor rooms. Have reviewed and repaired by a licensed insulation contractor.

Access panel doors are missing insulation on the backs of them. Cold air is allowed to migrate through the panel and into the third floor rooms. Have reviewed and repaired by a licensed insulation contractor.

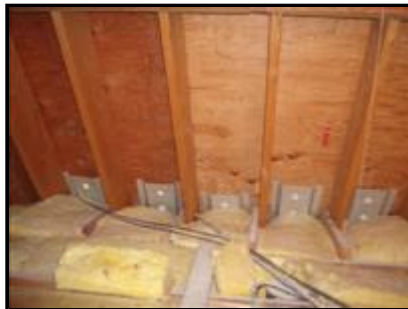
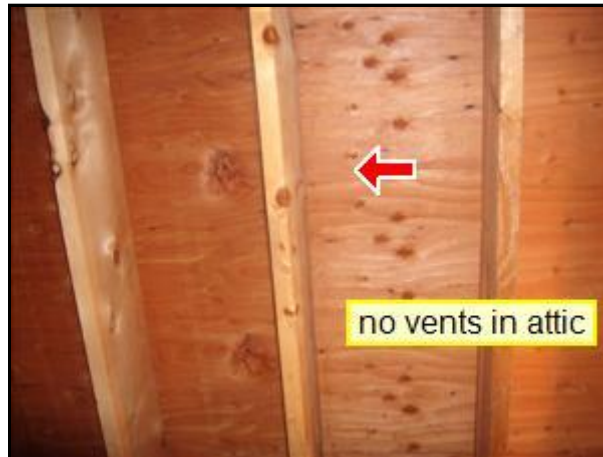
9.3 Picture 1

9.3 Ventilation was not added, when the most recent roof covering was installed. I recommend increasing the ventilation to promote life expectancy of covering.

Ventilation was not added, when the most recent roof covering was installed. I recommend increasing the ventilation to promote life expectancy of covering.
